Appendix C Existing Catchment Plan and On Site Drainage Arrangements

West Cambridge Masterplan Stage 1b Review

Ground Conditions and Land Quality

Project Ref: 31500 | Stage 1b | October 2014

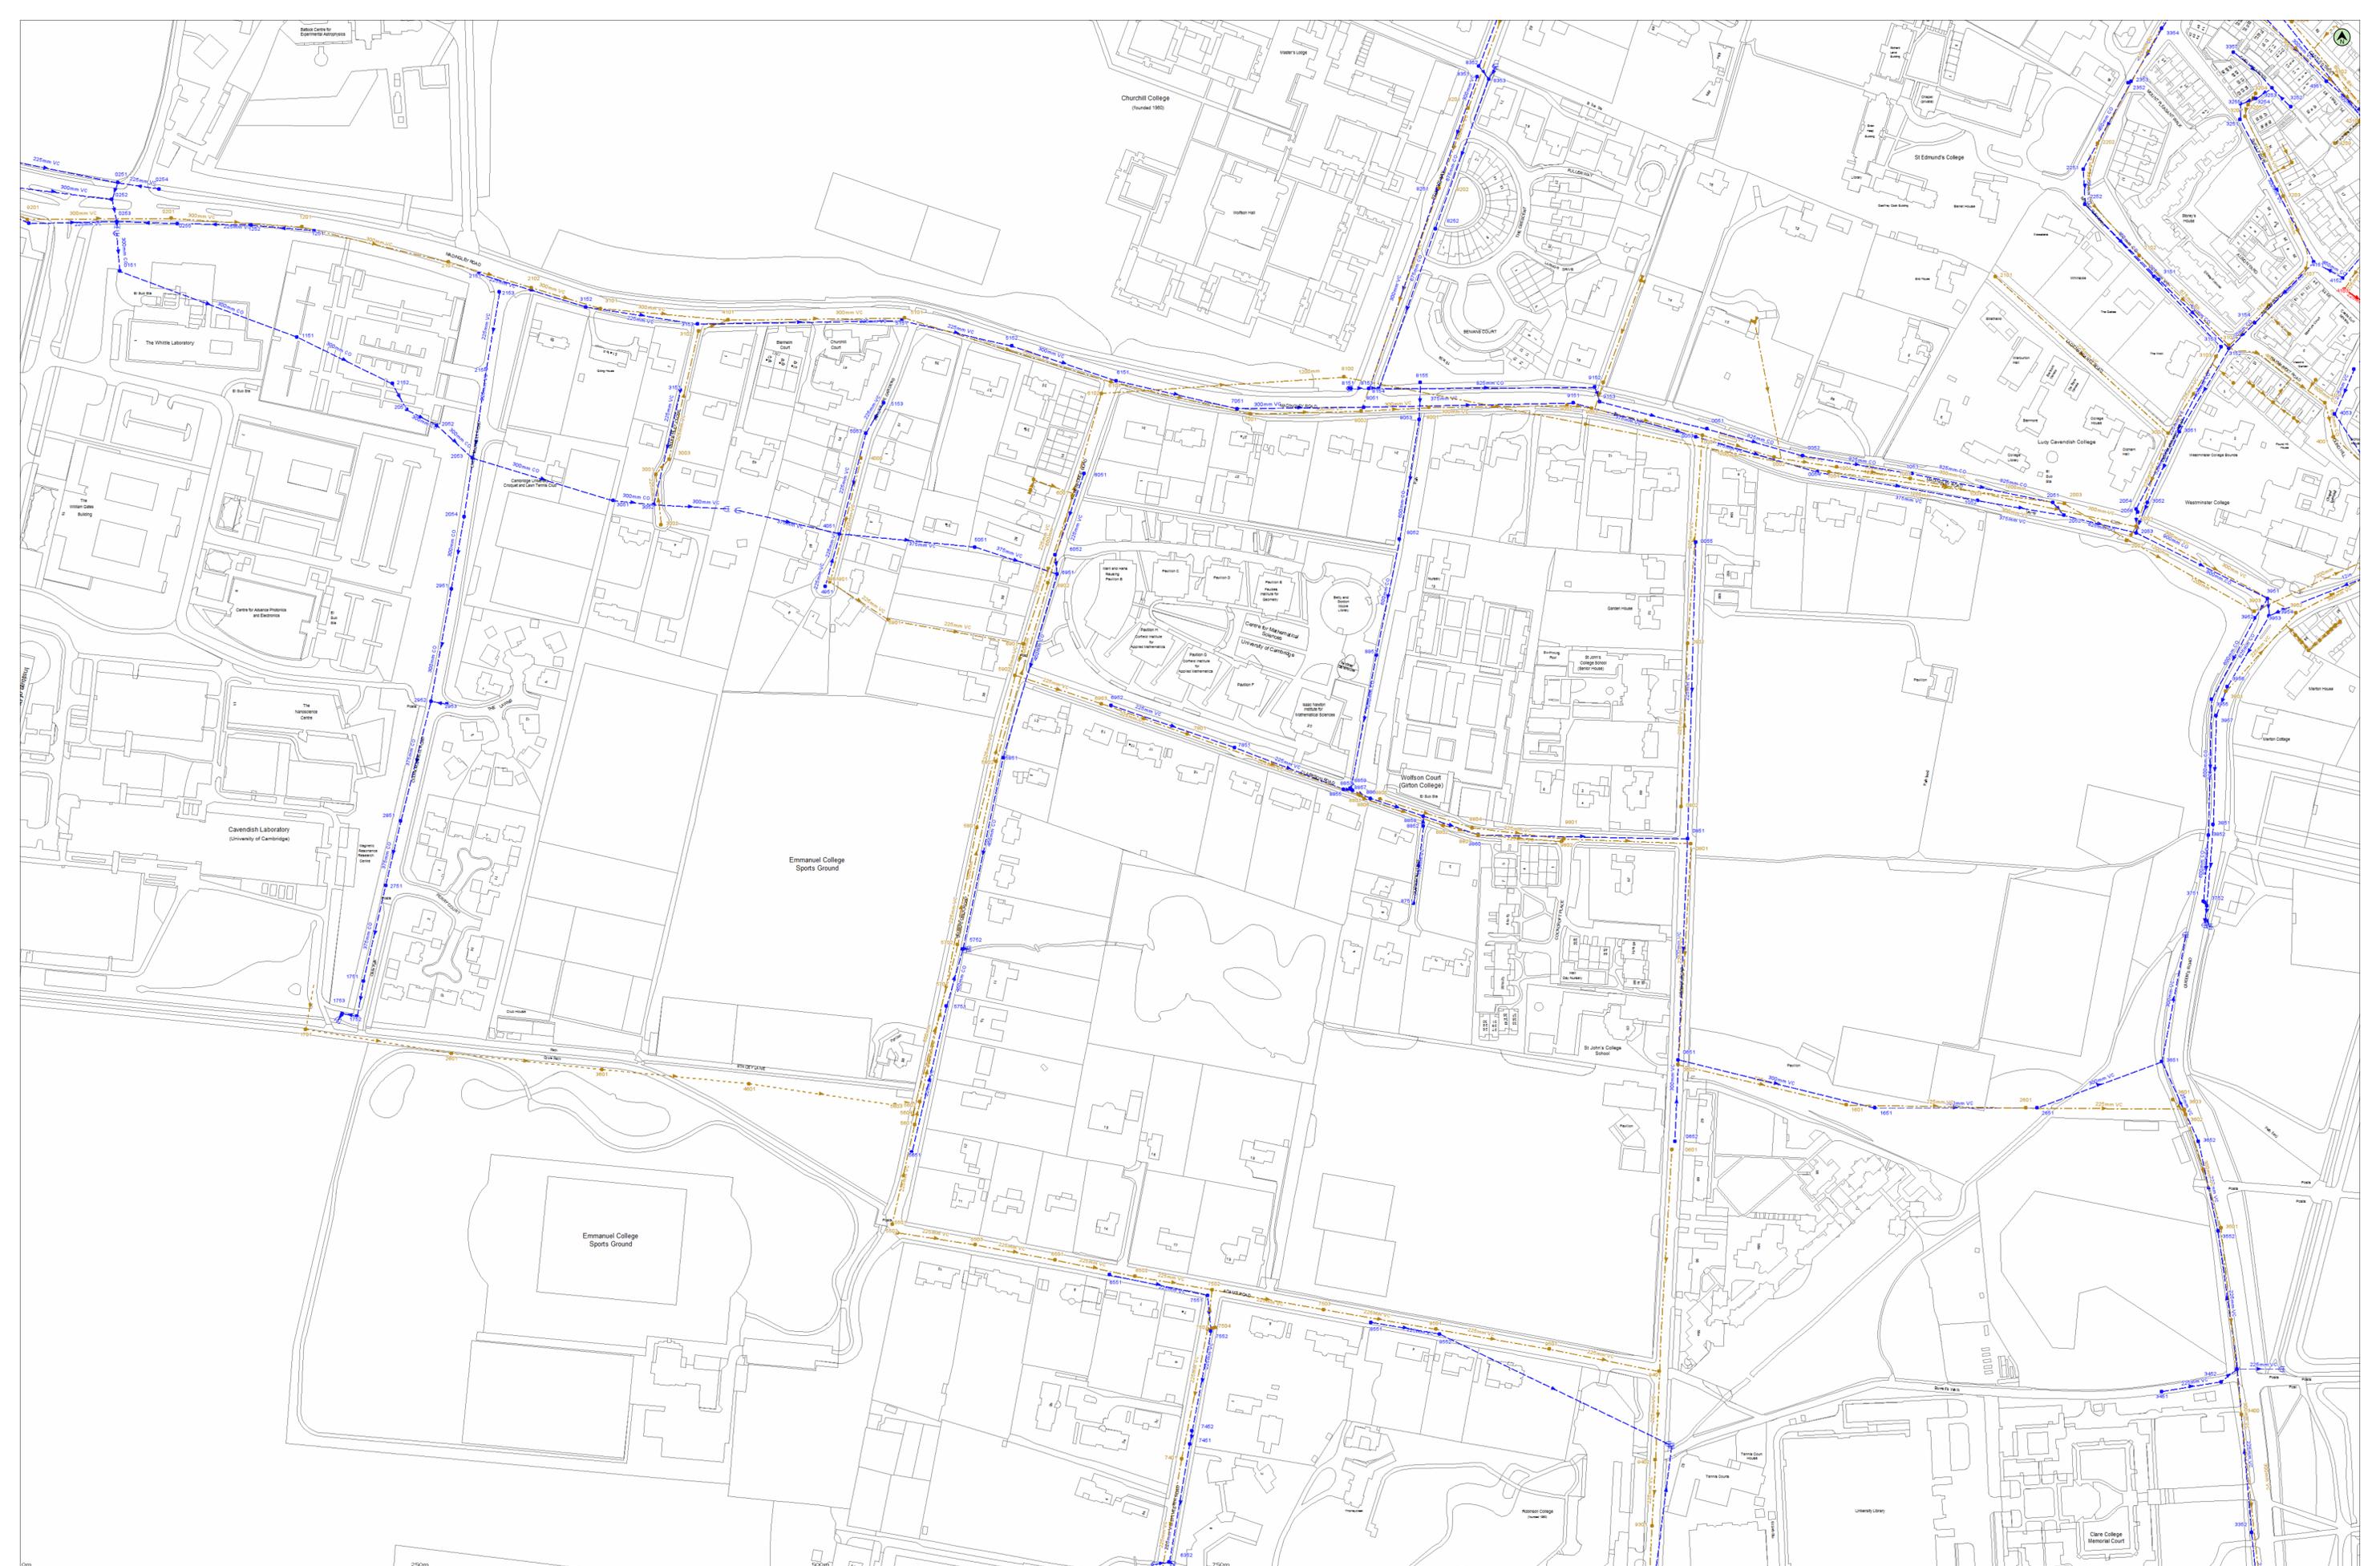
West Cambridge 2

© Crown Copyright and database rights. 2014 Ordnance Survey 100022432 Date: 09/09/14 Scale: 1:1250 Map Centre: 543705,258955 Data updated: 09/07/14 Our Ref: 111646 - 1 Wastewater Plan A1
